ANATOMY OF A WORKING TS-930S POWER AMPLIFIER

Version 2: Sept, 2020

The purpose of this document is to help HAMs determine whether or not his/her TS-930S RF power amp is in working condition, and if tests indicate that it is not, to provide some guidance with how to find the problem and repair it. The only tools that are needed for the first part of this work are a soldering pen and a decent Digital Multimeter (DMM) with diode test. Other functions such as capacitance, inductance, and/or frequency are useful, but not necessary for repairing the PA. But if you are planning to buy a DMM, get one with frequency also. Most testing here was done with an Amprobe AM-570. The specs say it reads frequency to 20 MHz, but mine reads accurately to 43.500 MHz!

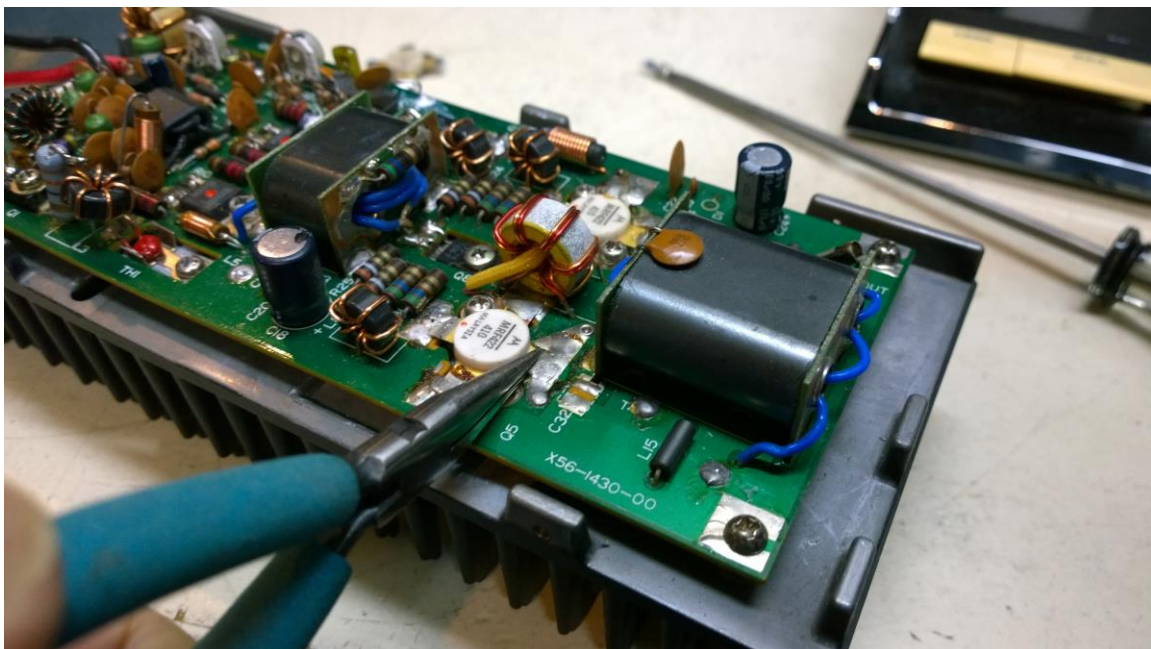
The only way to isolate the MRF422 Collectors from the board is to unsolder one end of both L14 and L15, OR by lifting up both Collector tabs. Unsoldering L14 and L15 requires removing the PA board from the heatsink, whereas lifting the collector tabs does not. I like to use fine tip needle-nose pliers for this job. Removing the adjacent mounting screw makes this easier.

If lifting the Collector tabs causes the readings across the PA power leads to return to normal, then one or both of the Finals are leaky or shorted. If only one IS bad and you have a spare with the same color dot, then you might be able to replace just the bad final. I would use a transistor analyzer like a Peak DCA55 to make sure their gains are close. If they aren't, replace both as a pair.

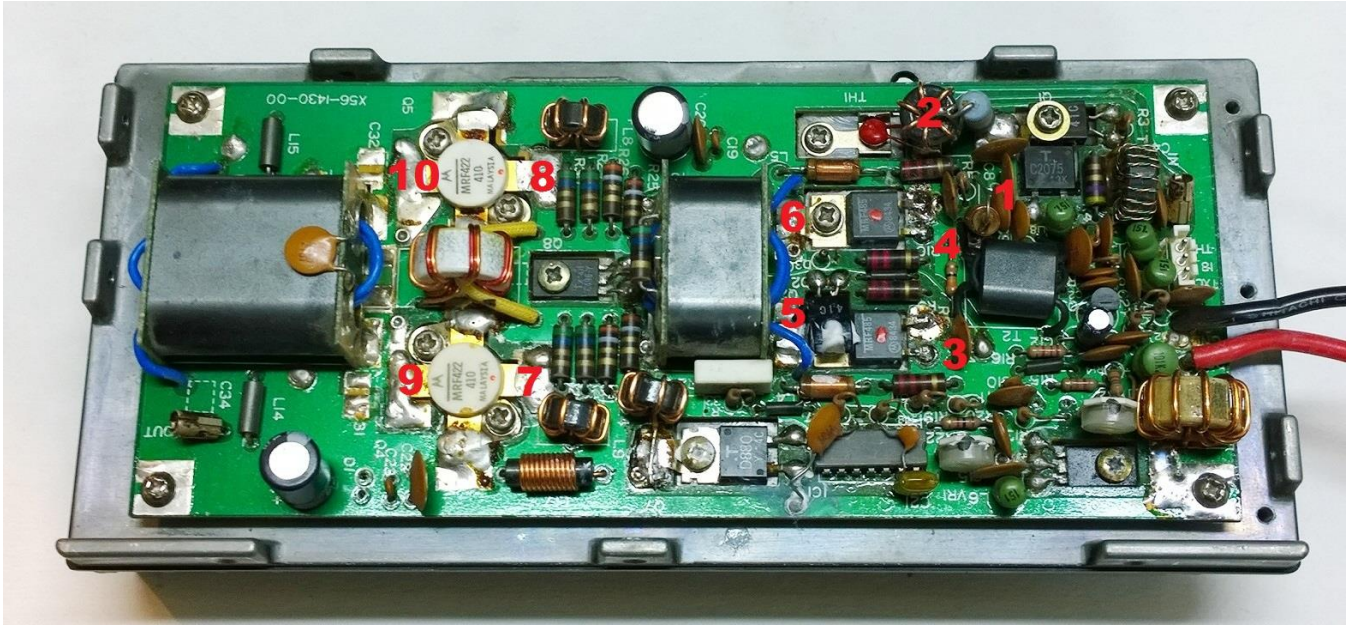
If you have an oscilloscope at your disposal, then testing your PA is quick and easy. The photo below shows the PA with the test points identified by numbers, which correspond to Scope waveforms on the following pages.

Basically, there are 10 amplifier circuit signal test points:

- 1 Top of RF choke “tower” L18 – signal input to Q1 from the signal unit
- 2 Top of RF choke “tower” L3 – signal output from T1 to the drivers
- 3 & 4 The base tab of each driver
- 5 & 6 The collector tab of each driver
- 7 & 8 The base tabs to each final
- 9 & 10 The collector tab of each Final

TEST POINT(S)	SIGNAL	EXPECTED P-P RF OUTPUT
1	Input to Q1	Between 0.2-0.3 RF volts (200-300 mV)
2	Output from Q1	Between 1 & 1.5 RF volts
3 & 4	Bases of Q2/Q3	Between 2 & 2.5 RF volts
5 & 6	Collector tabs of Q2/Q3	Between 5 & 8 RF volts
7 & 8	Base tabs of Q4/Q5	Between 2 & 4 RF volts
9 & 10	Collector tabs of Q4/Q5	Between 24.5 & 29.5 RF volts

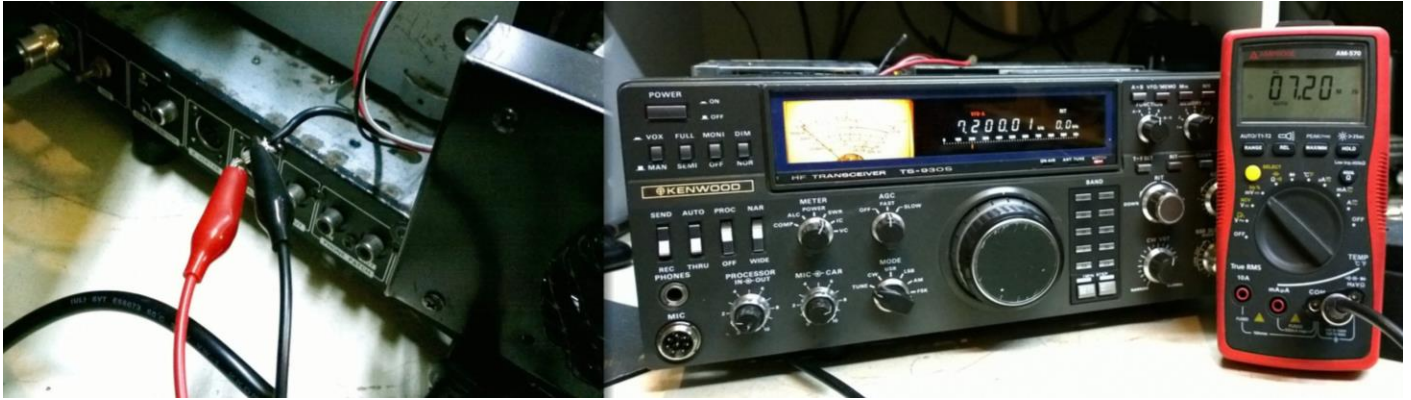
Connect your leads to the end of the RF cable to the PA input as shown below. Just don't bend the little center pin. The cable shown below is black instead of gray because I replaced the original with a longer one that I made.

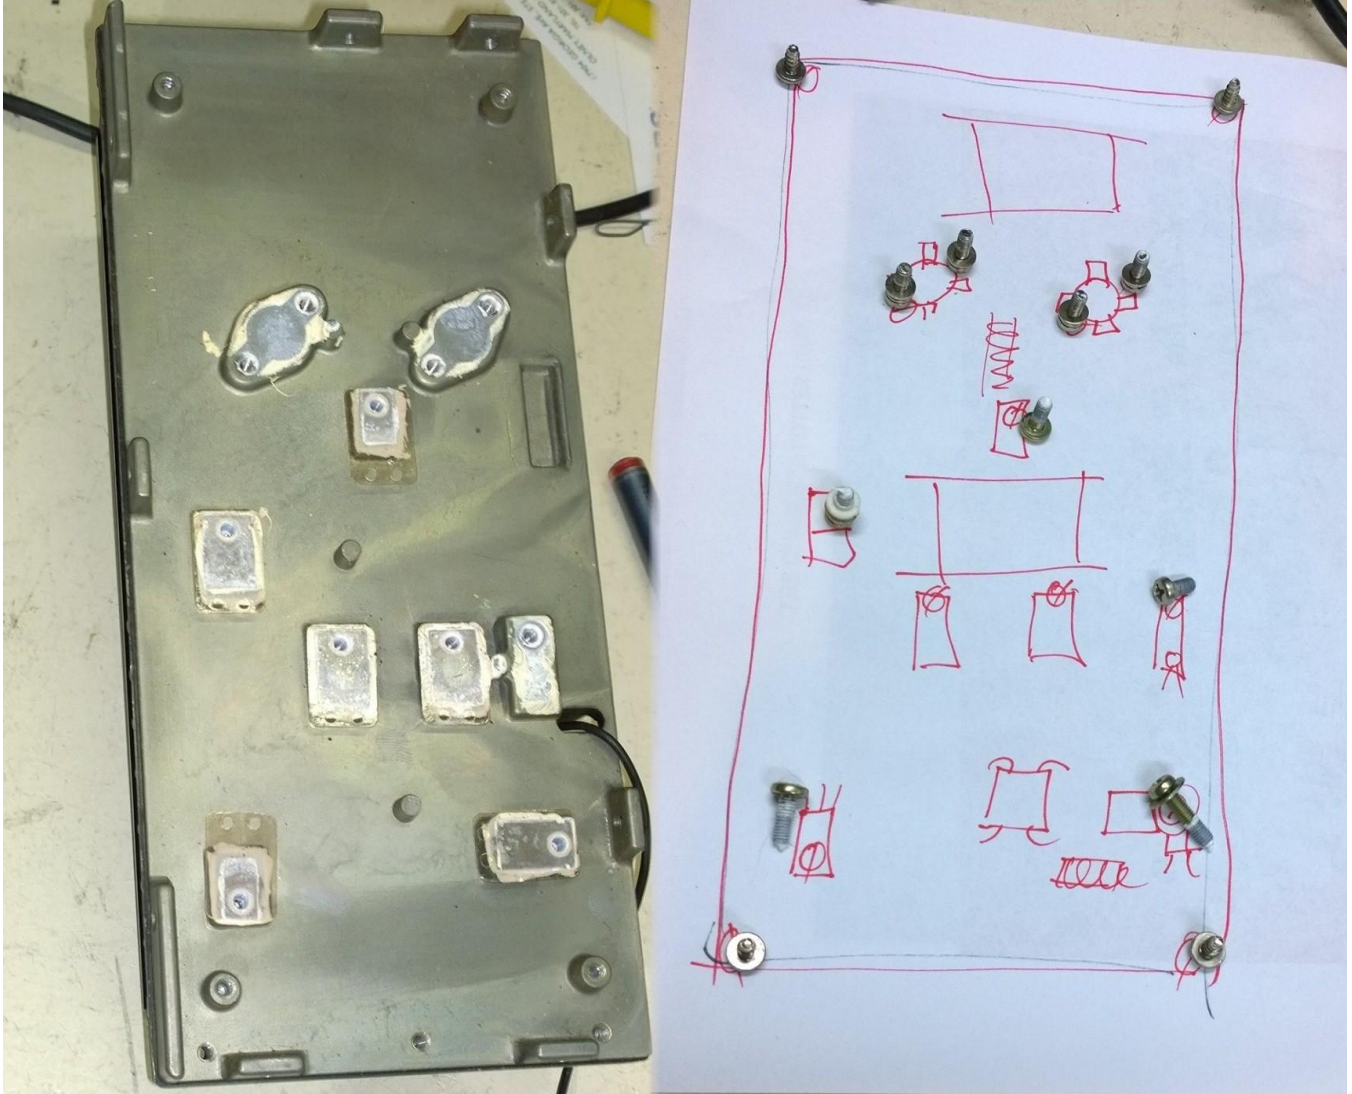
The mica insulator and screw locations.

The driver mounting screws have nylon shoulder washers on them like Q7. They're not shown in the photos.
